Subject: Annual Inspection Report
Tuskegee (Moton Field) Municipal Airport

ANNUAL INSPECTION REPORT

TUSKEGEE (MOTON FIELD) MUNICIPAL AIRPORT

October 21, 2010

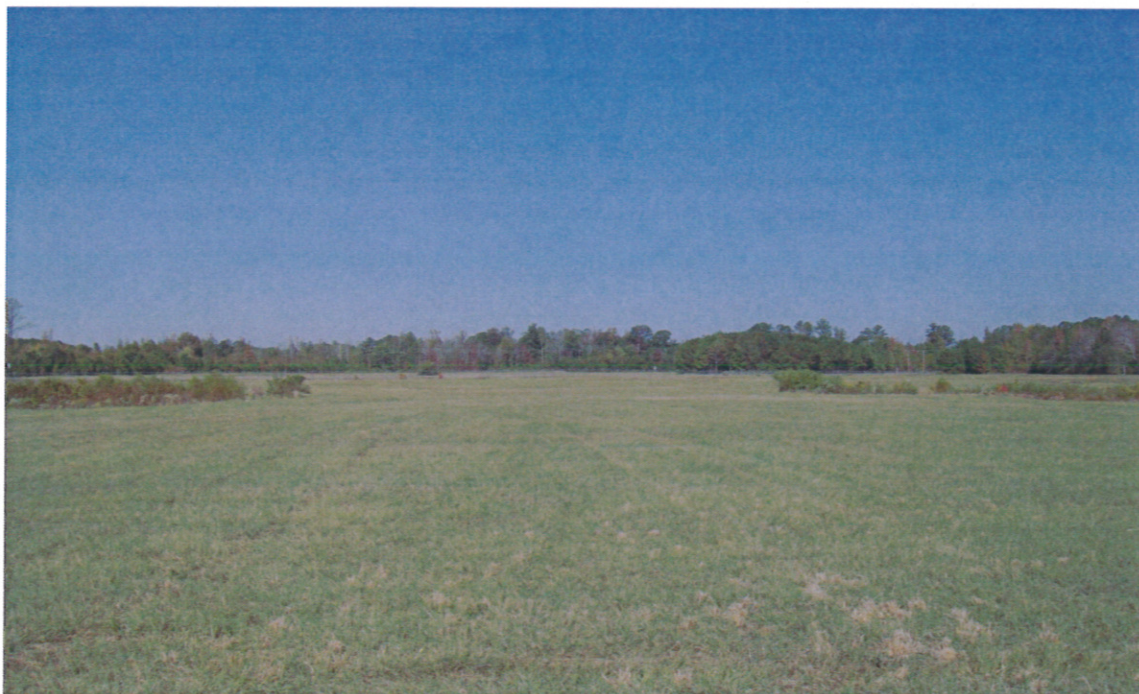
Photo # 1 – Rwy 13 Approach

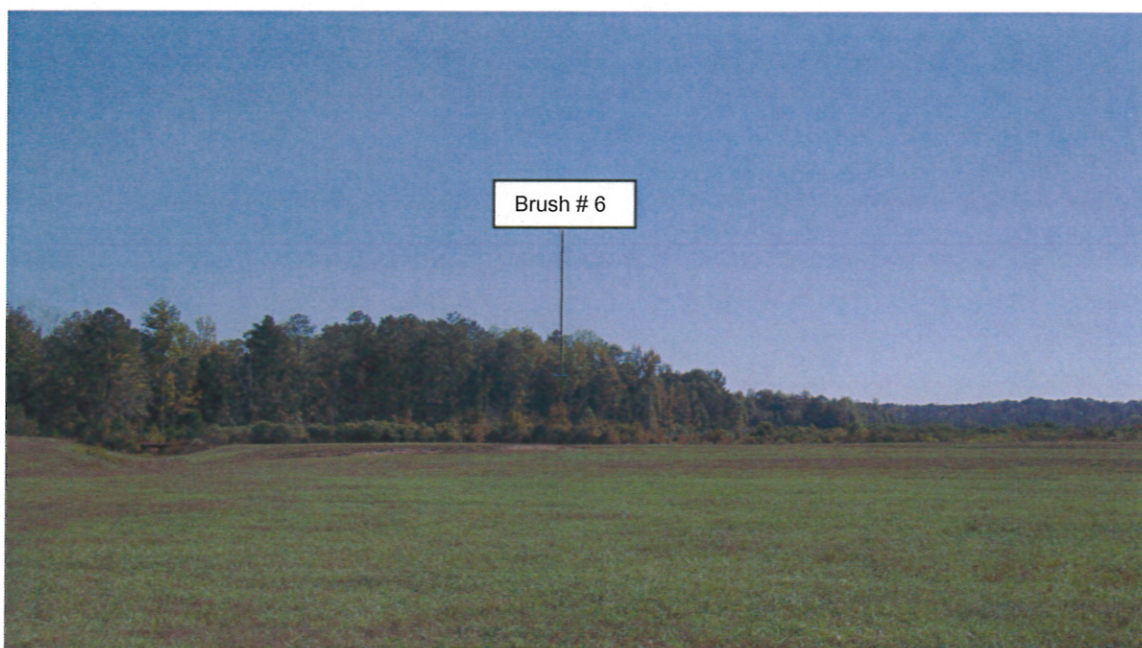
- Runway 13 – No obstructions (See Photo # 1)
- Runway 31 – No obstructions to the ALDOT 20:1 approach/departure path; however brush identified as Brush # 6 violates the FAA 34:1 approach slope within the FAA Runway Protection Zone (See Photo # 2, and Appendix # 2).

Photo # 2 – Rwy 31 FAA RPZ Obstructions

- Brush is growing along the airport security fence beneath the approach/departure path of runway 31 and should all be removed along with the obstruction to the FAA's RPZ.

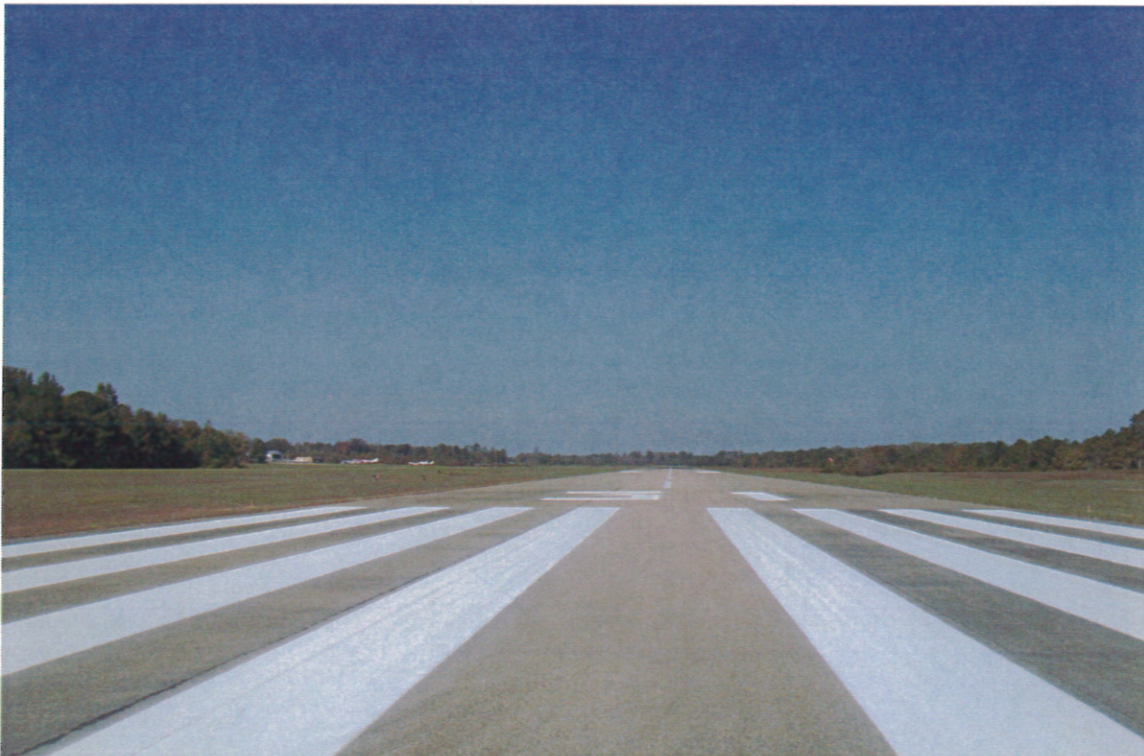
- An airport marking project has recently been completed and the markings are in good condition (See Photo # 3).

Photo # 3 – NPI Markings

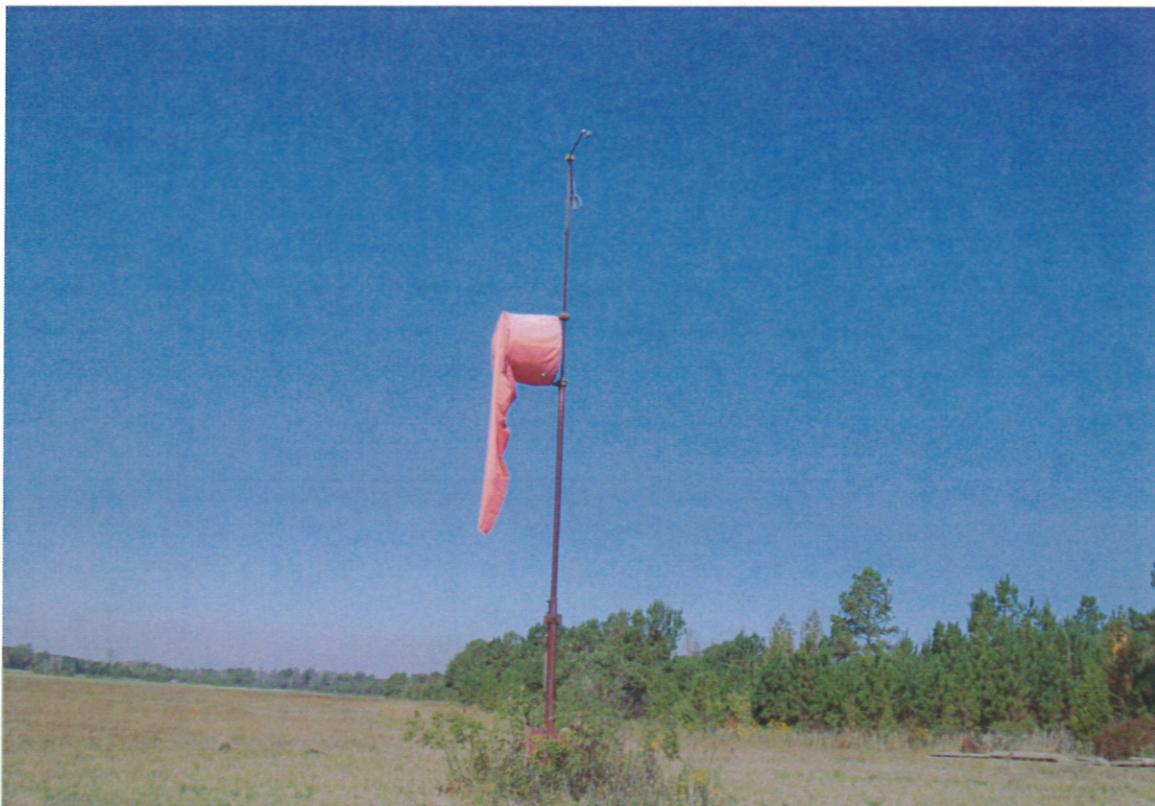
- The wind direction indicator (windsock) was operational. However light fixtures were missing and no lights appeared to be operational (See Photo # 4).

Photo # 4 – Wind Direction Indicator

- A new wind cone structure is being erected as part of an ongoing lighting project and should be completed before the end of November.

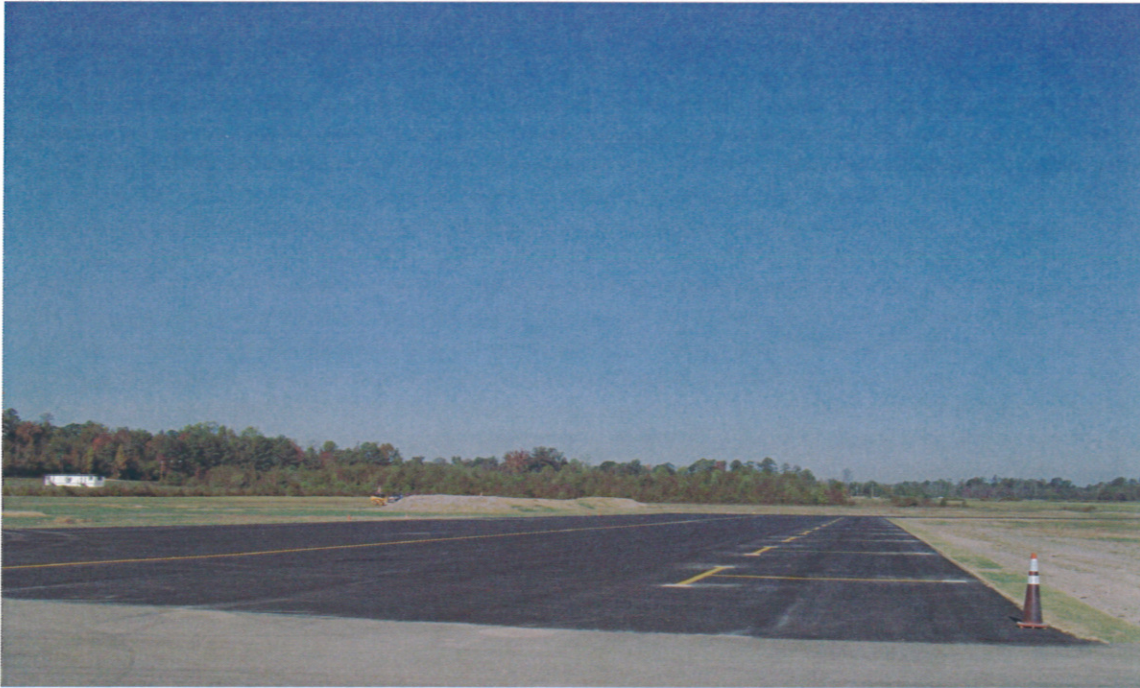
- The airport pavement surfaces are in good condition (Photo # 5).

Photo # 5 – New Ramp Area

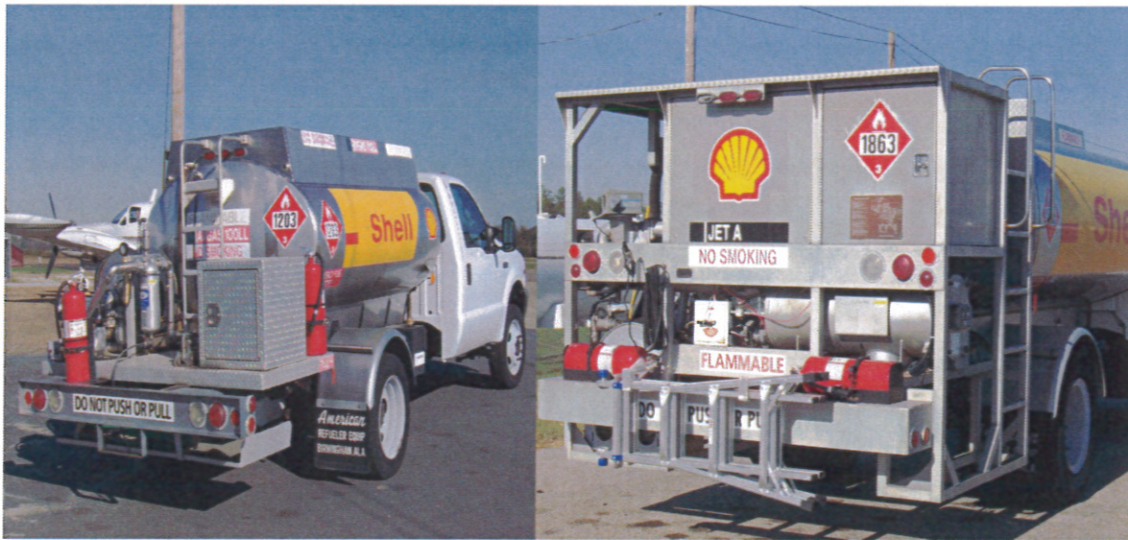
- The fueling area meets the requirements established by the Alabama Department of Transportation. However, the State of Alabama Department of Agriculture and Industries may have additional requirements for fueling systems that were not considered during this inspection.

Photo # 6 Fuel Trucks

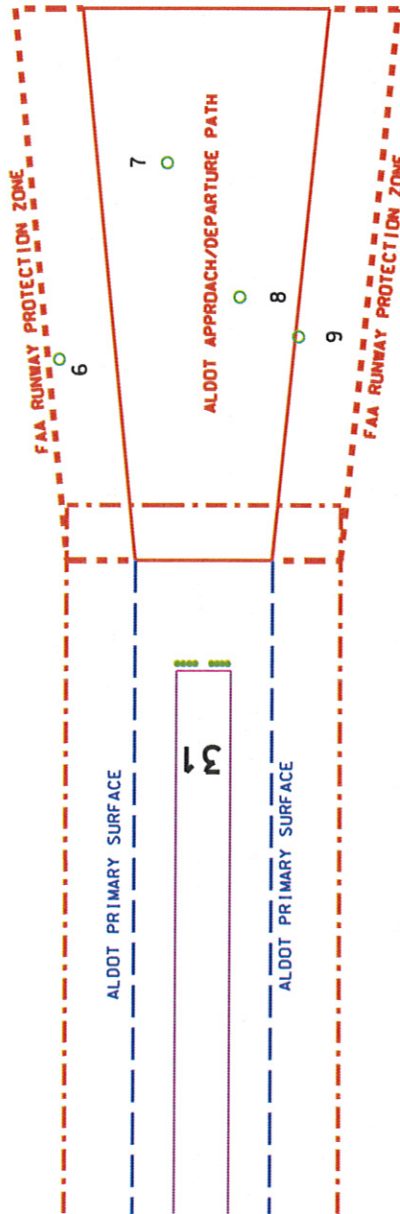
REQUIREMENTS FOR STATE AIRPORT LICENSE RUNWAY 31

- * 6. BRUSH - 17.5' ABOVE RUNWAY END
624' FROM RUNWAY
265' RIGHT OF CENTERLINE
24:1 OBSTRUCTION CLEARANCE SLOPE

* NOT AN ALDOT OBSTRUCTION
